Results from RICOWI Hail Investigation Program (HIP) May 24, 2011 Storm

“War on Hail” Symposium
Irving, TX

Hail Investigation Program (HIP) Mission statement

May 24, 2011 Event

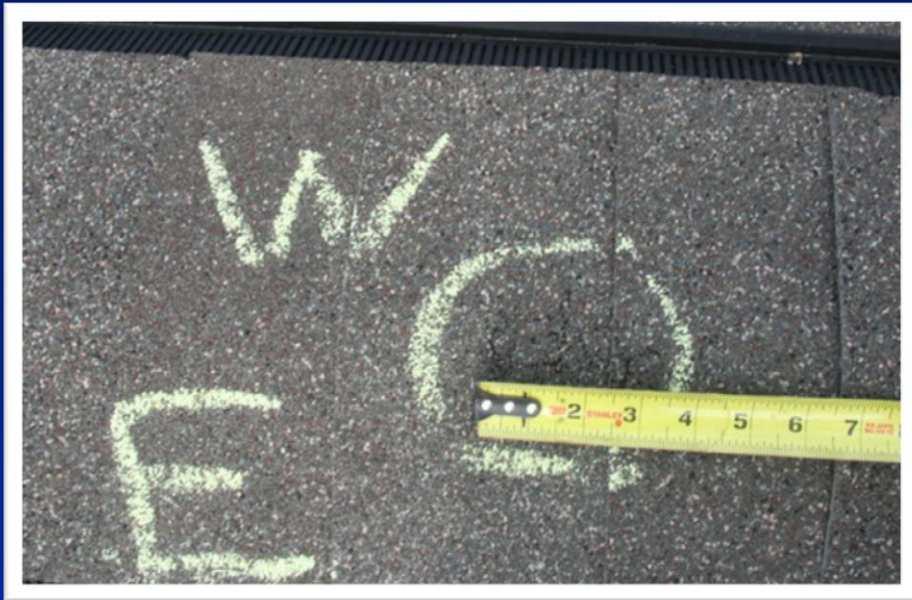
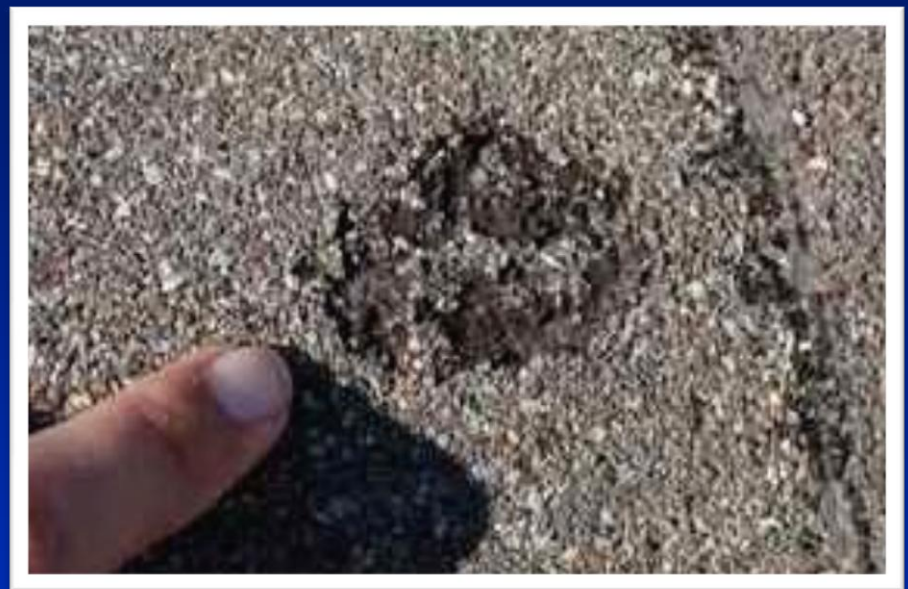
Site 2.06: Max Hail Size 2.25" (Puncture)

Standard Asphalt Shingles

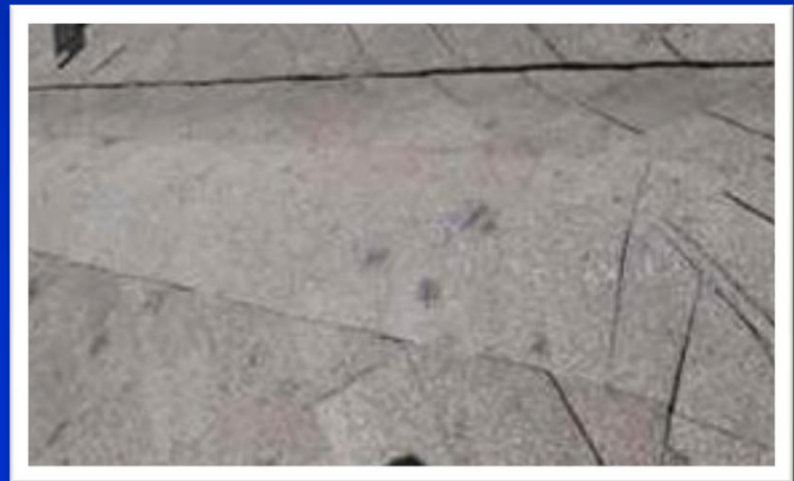
Often greater
damage to ridge/hip
due to lack of support

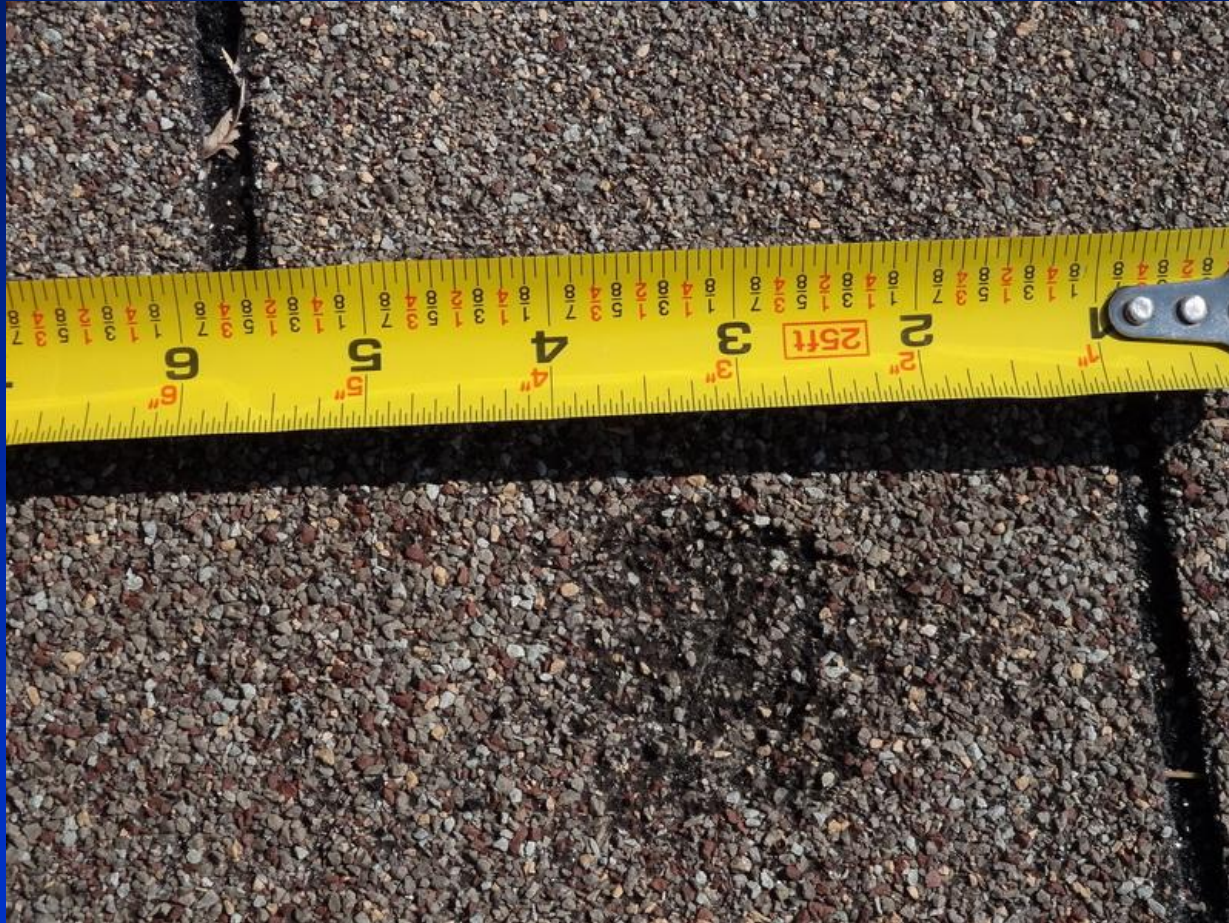
Site 5.07: Max Hail Size 2.5"
(Fracture/Rupture)

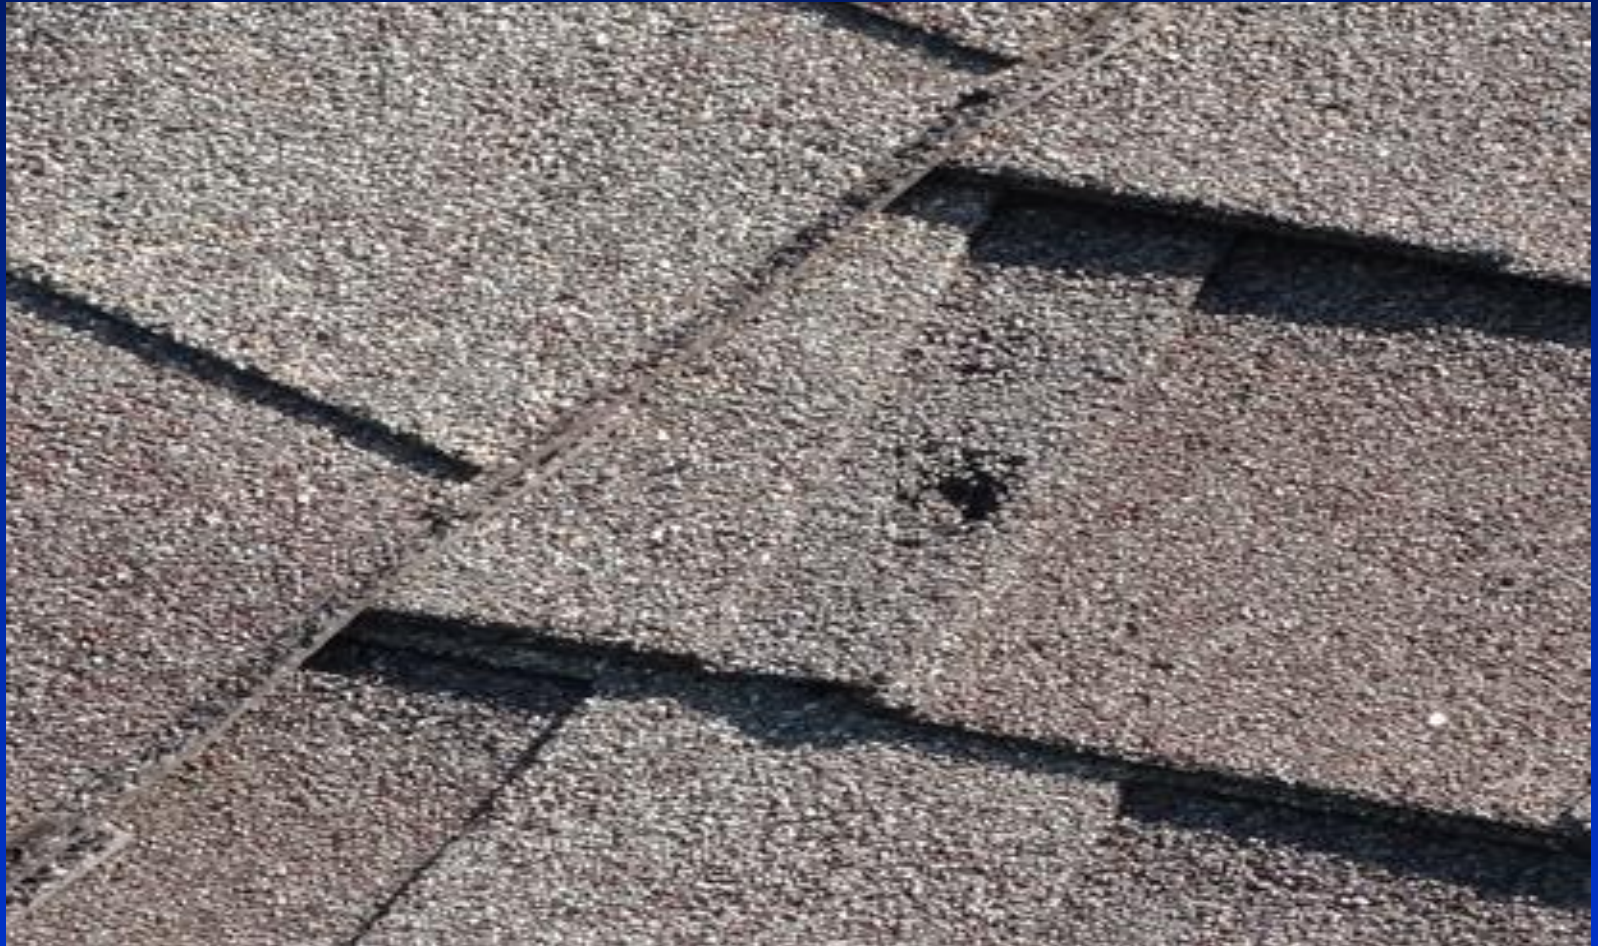
Site 5.12: Max Hail Size 2.5"
(Fractures/Punctures)

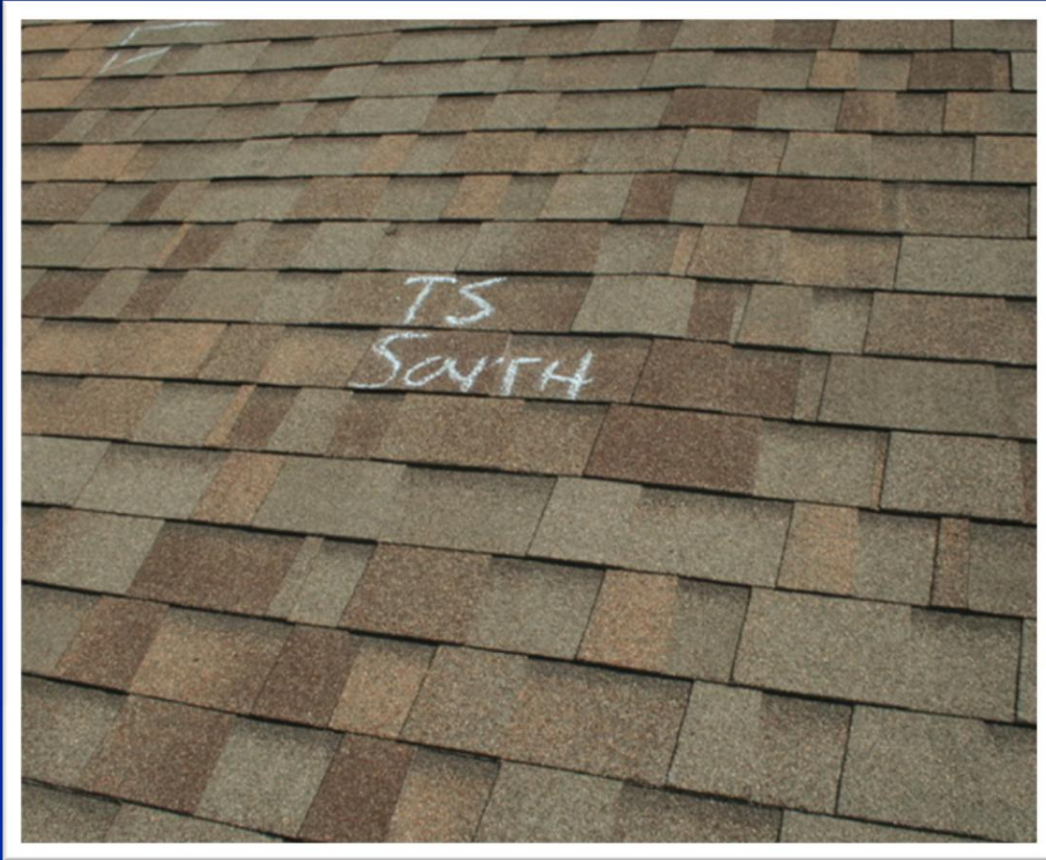
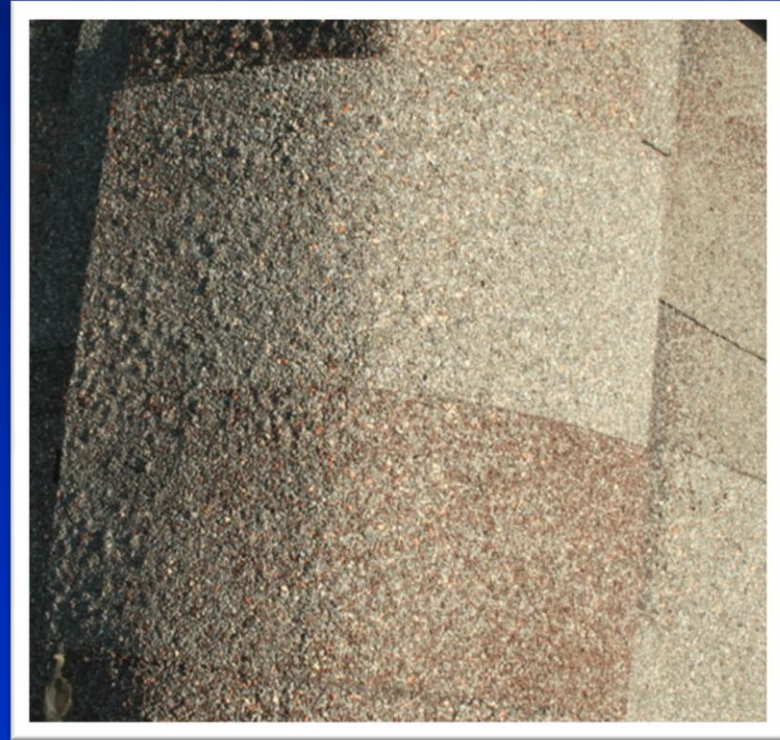
Site 2.13: Max Hail Size 1.5" (No Damage)

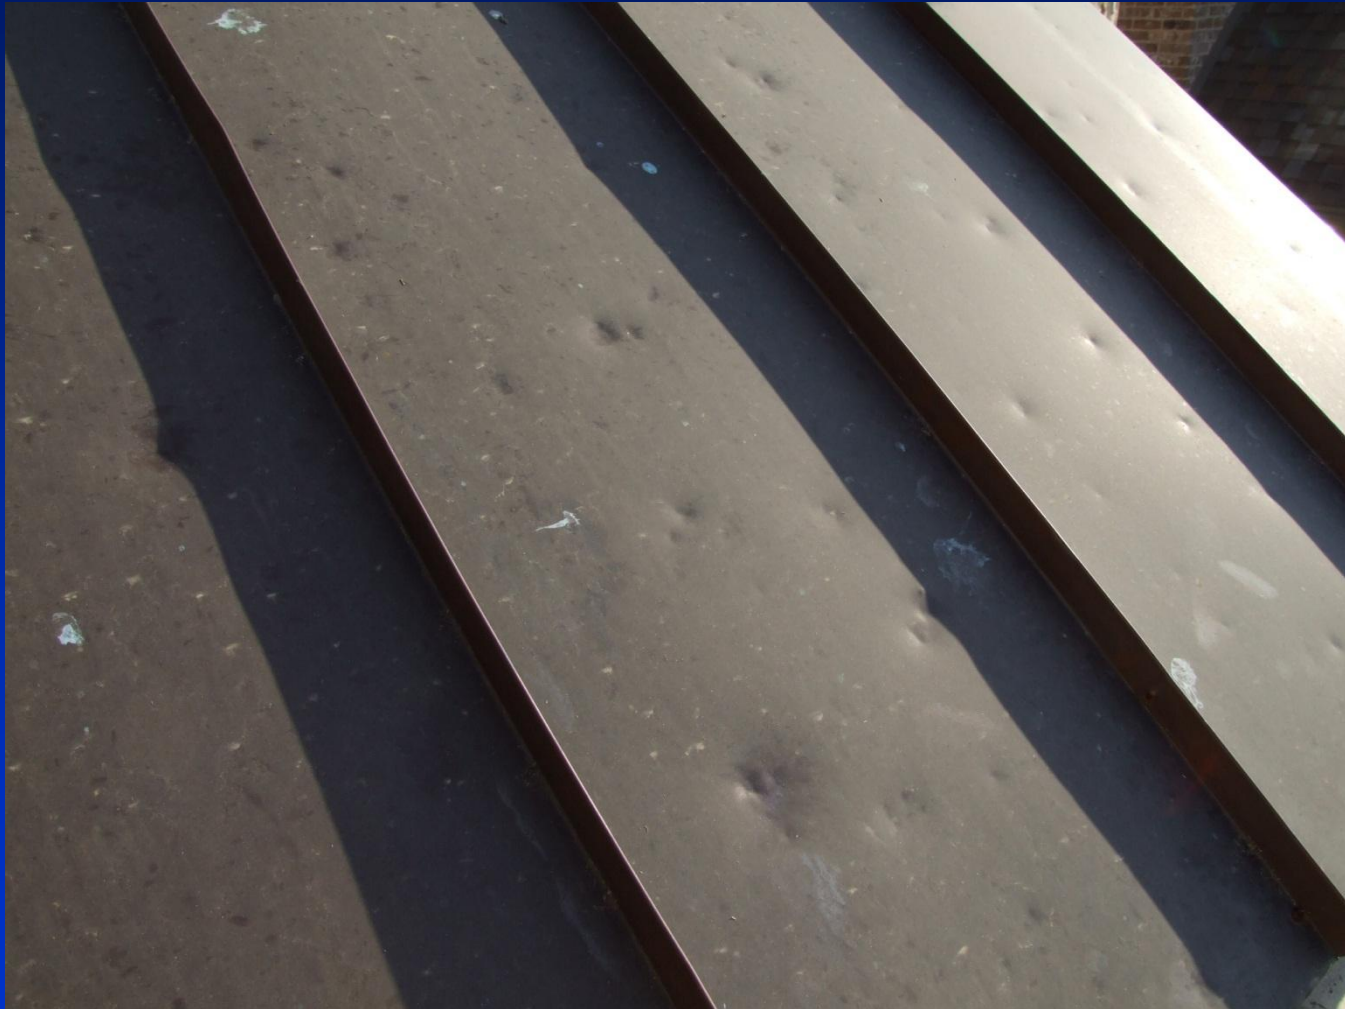
Site 6.15: Max Hail Size 2.5" (Dents)

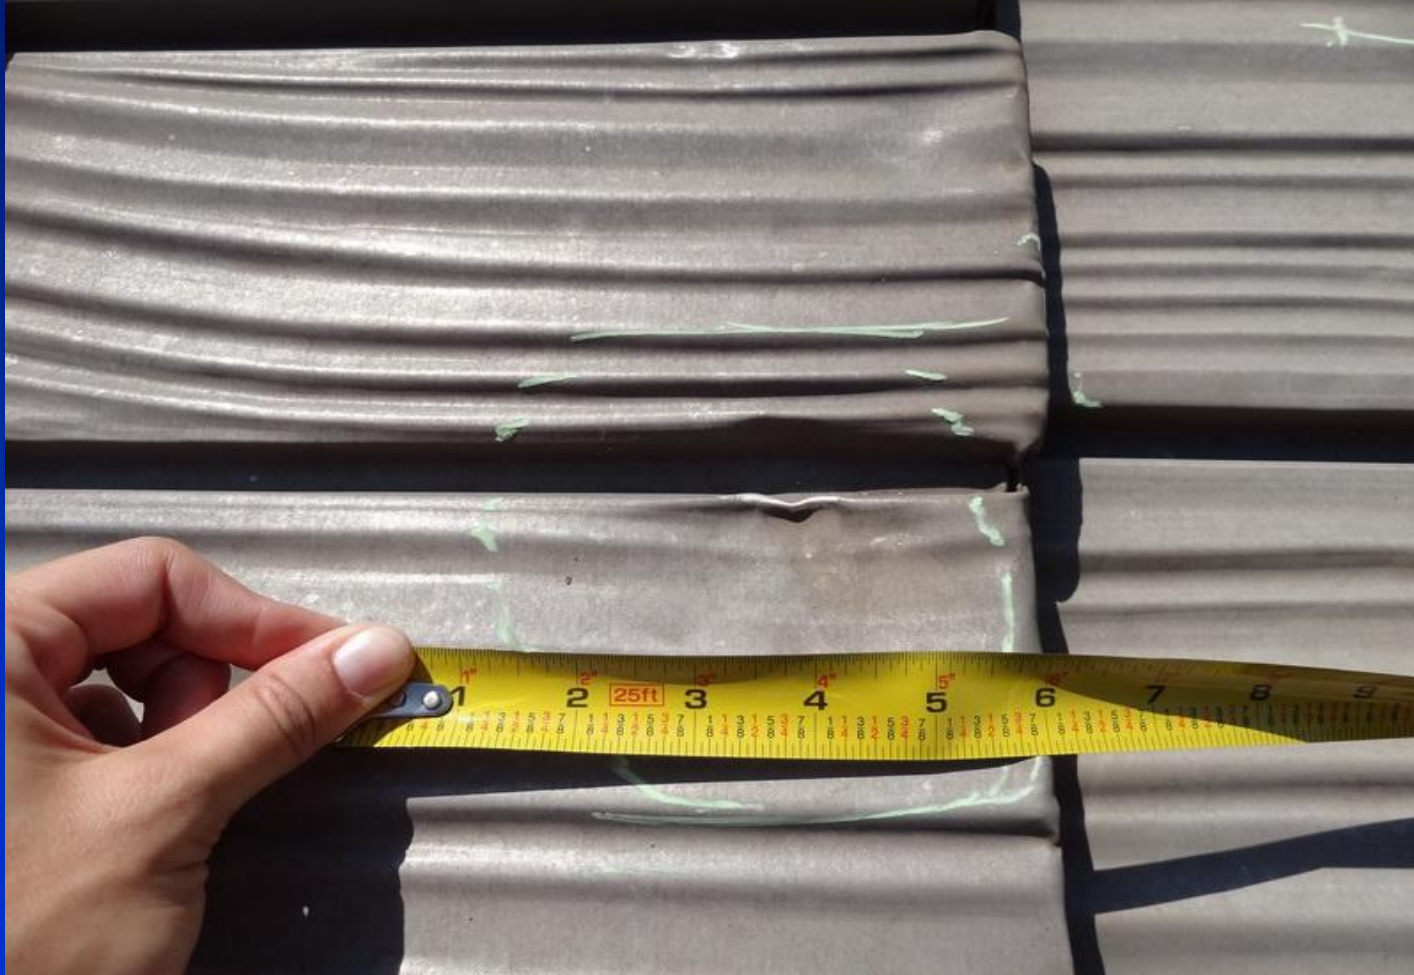
Site 5.15: Max Hail Size 2.5" (Dents)

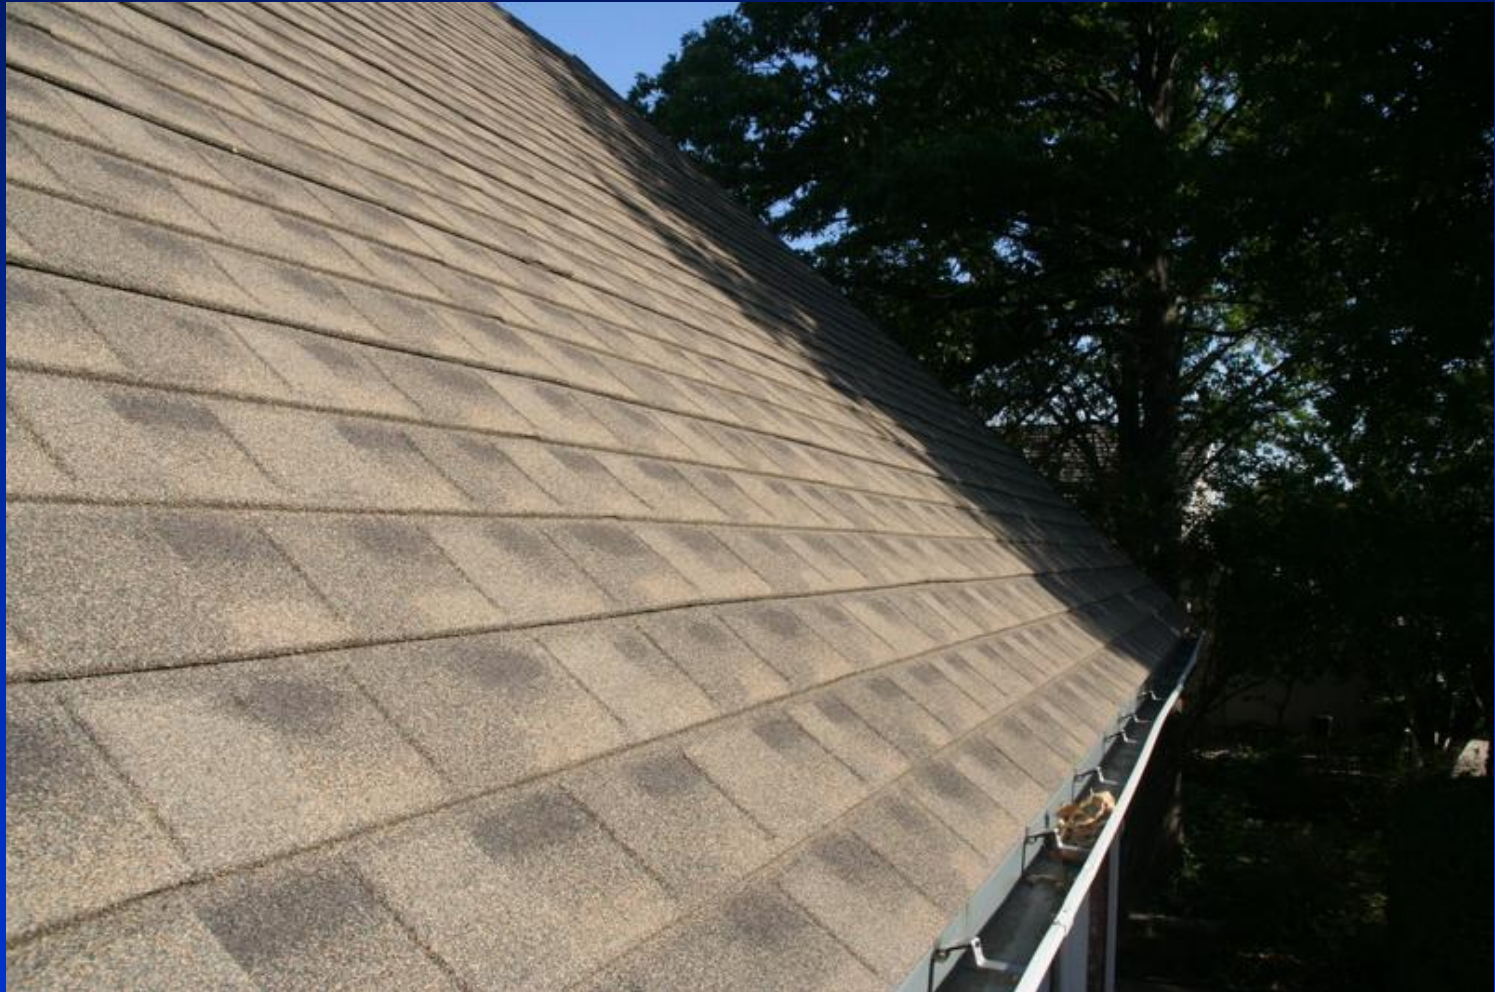
Site 2.14: Max Hail Size 1.5" (No Dents)

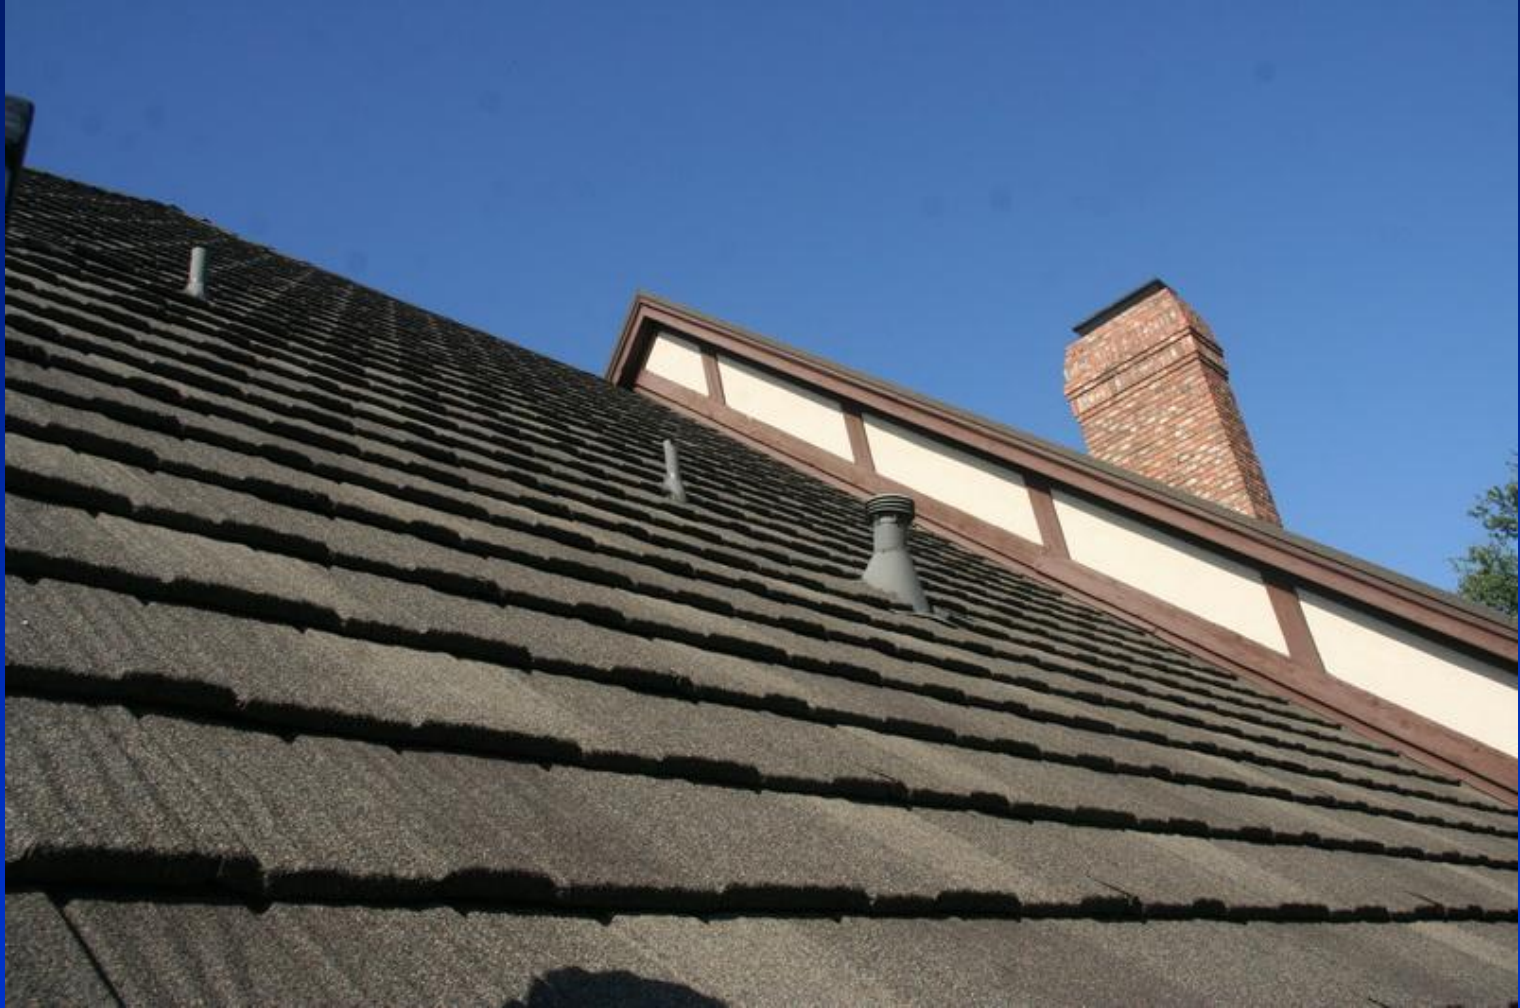
Site 2.16: Max Hail Size 2.5" (No Hail Dents)

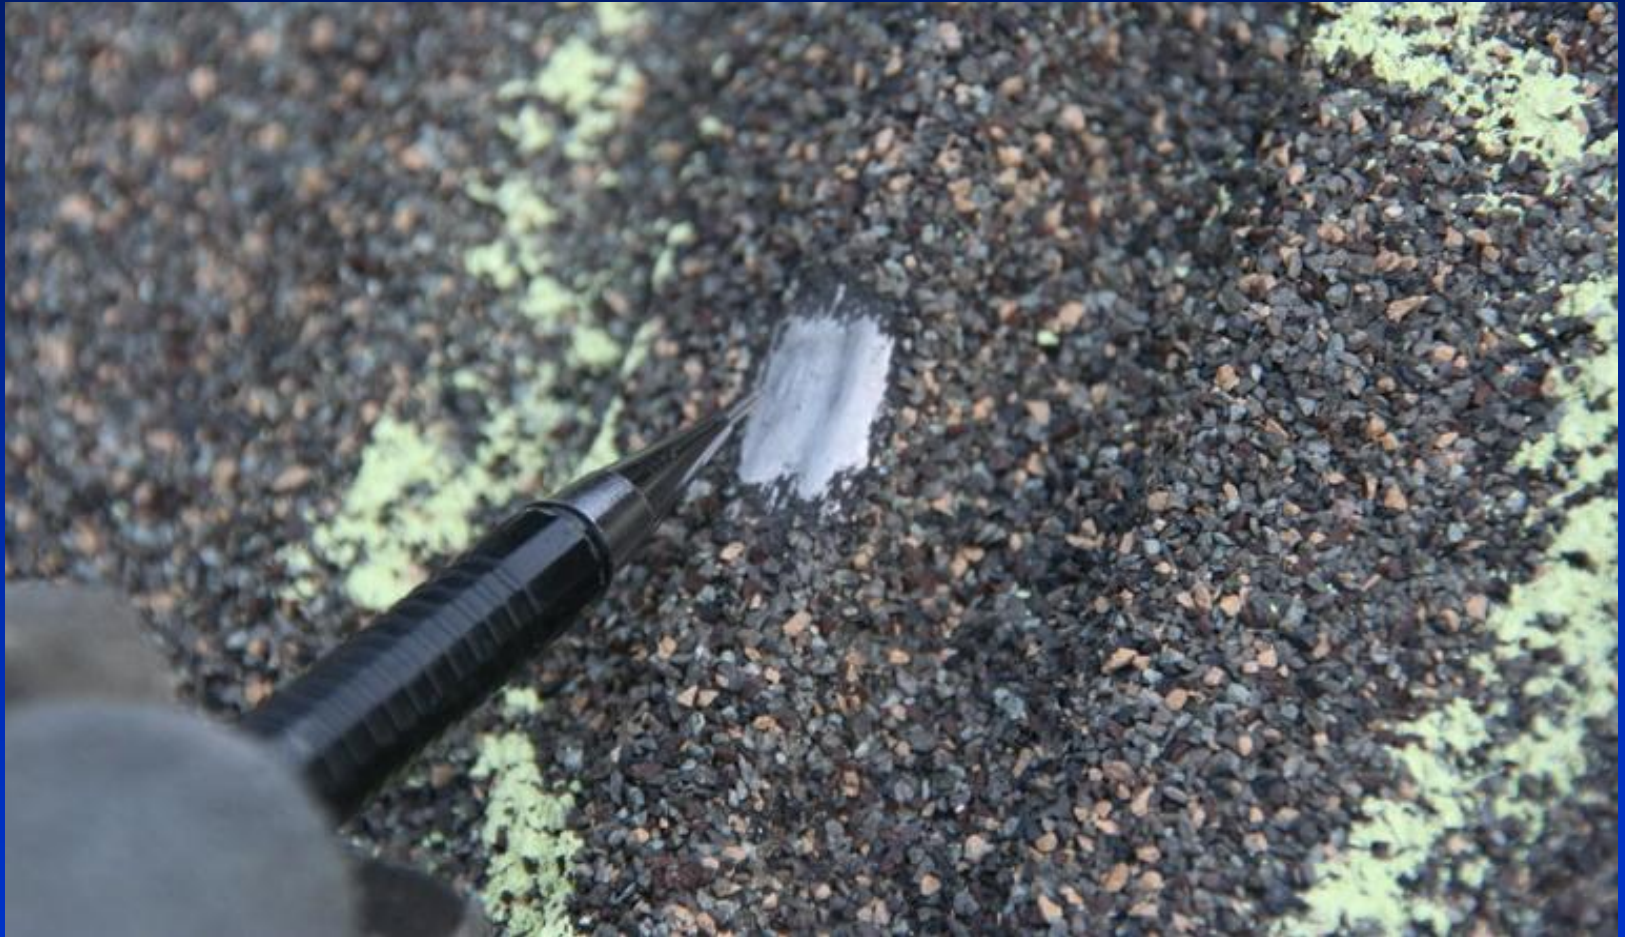
Site 2.16: Scratches and granule removal from mechanical contact

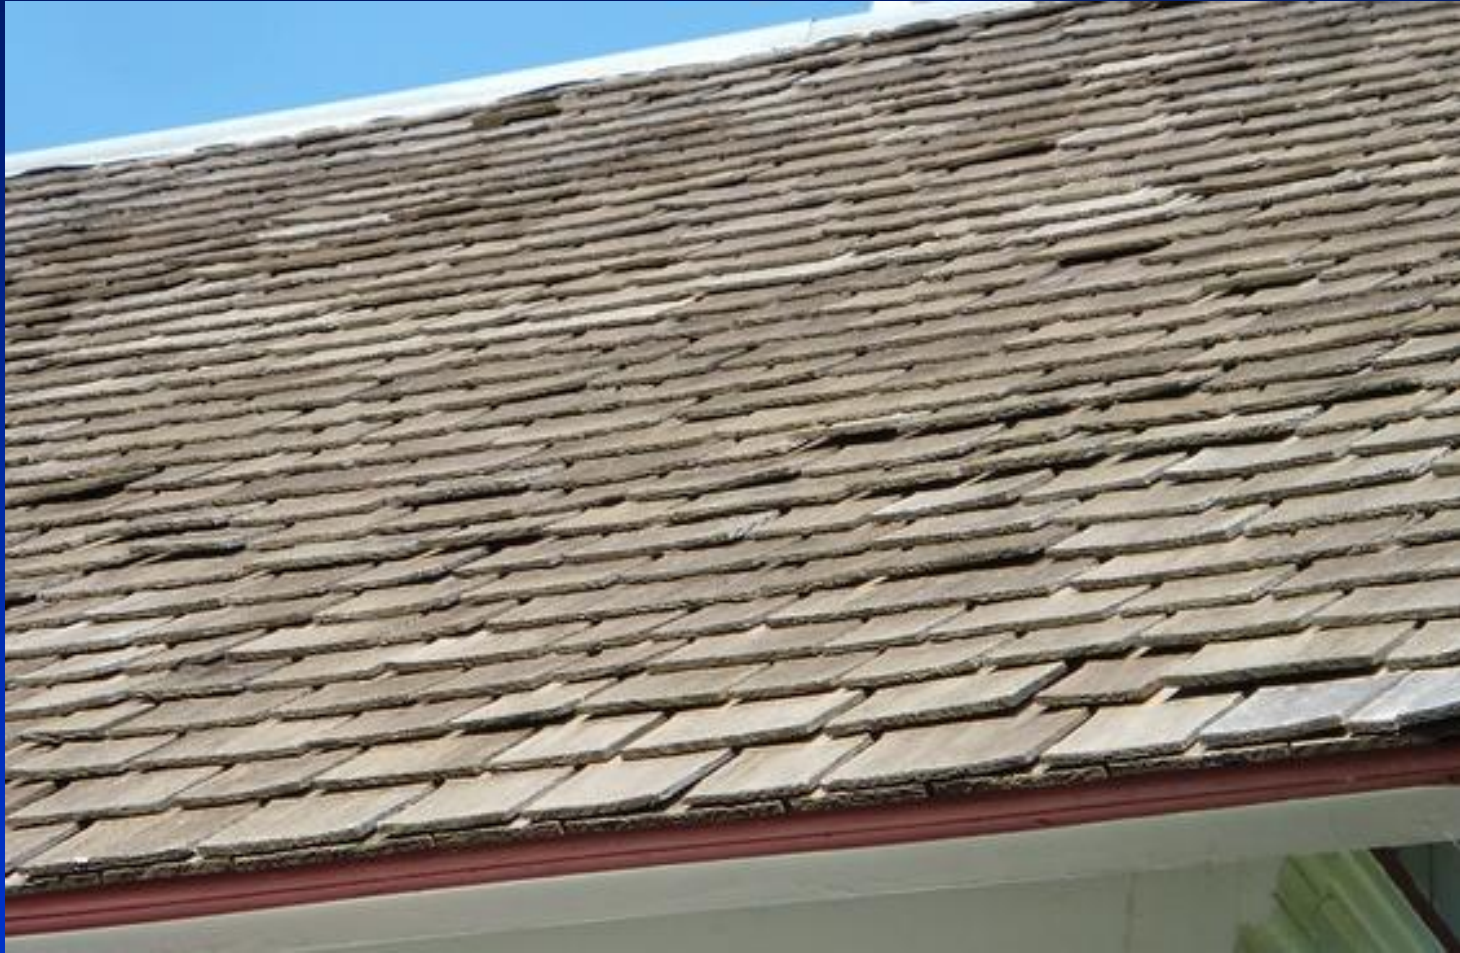
Site 7.02: Max Hail Size 1.0"
Surface marks without splits only

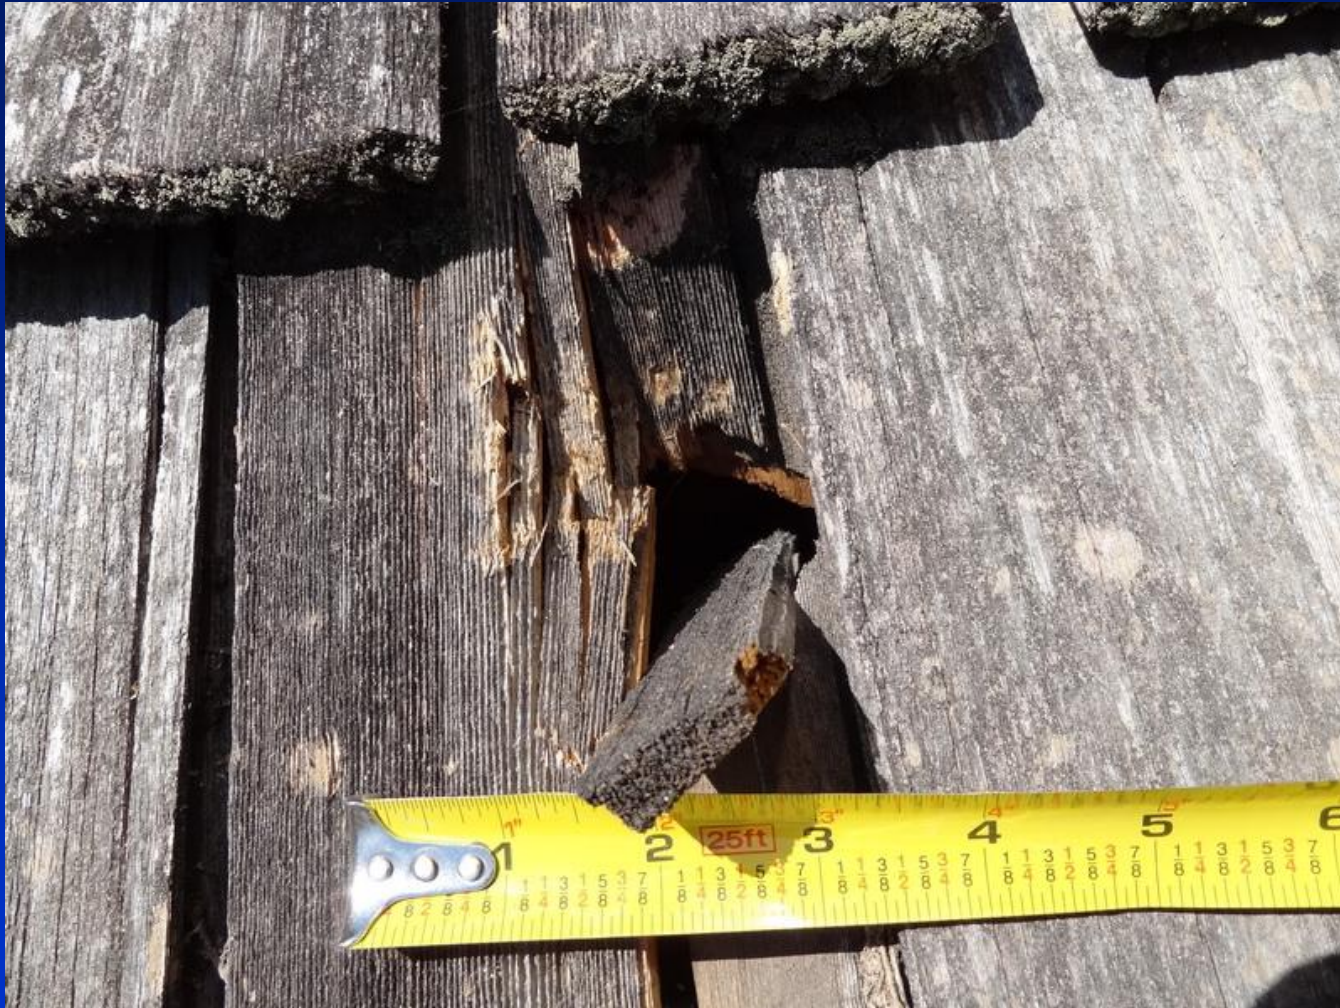
Site 5.17: Max Hail Size 2.25"
Splits and punctures

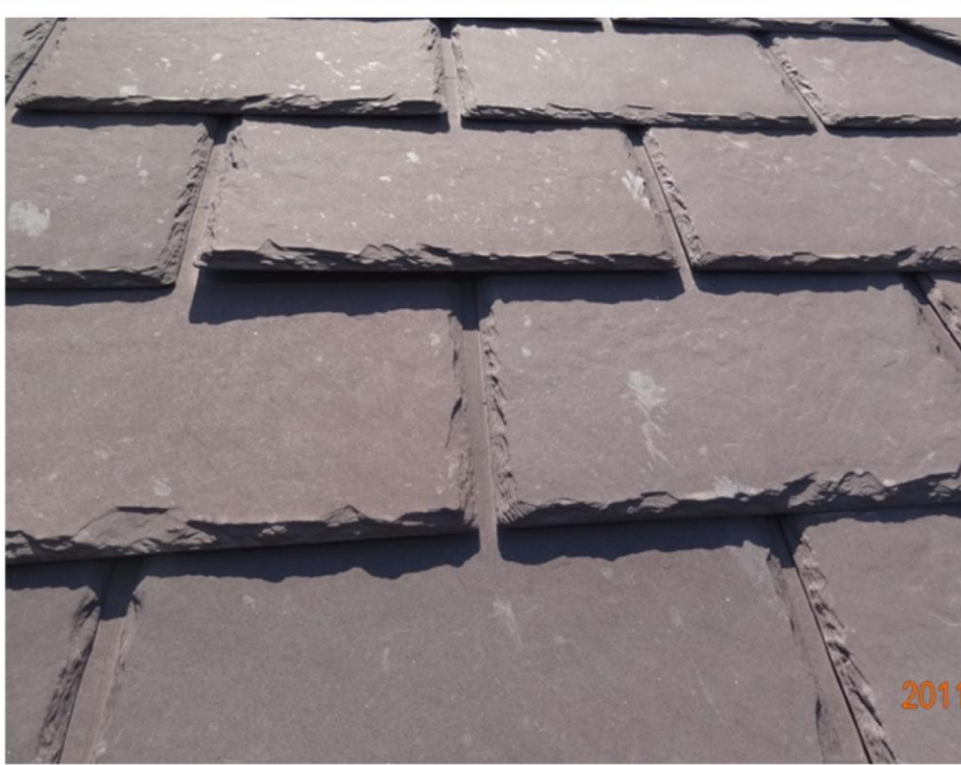
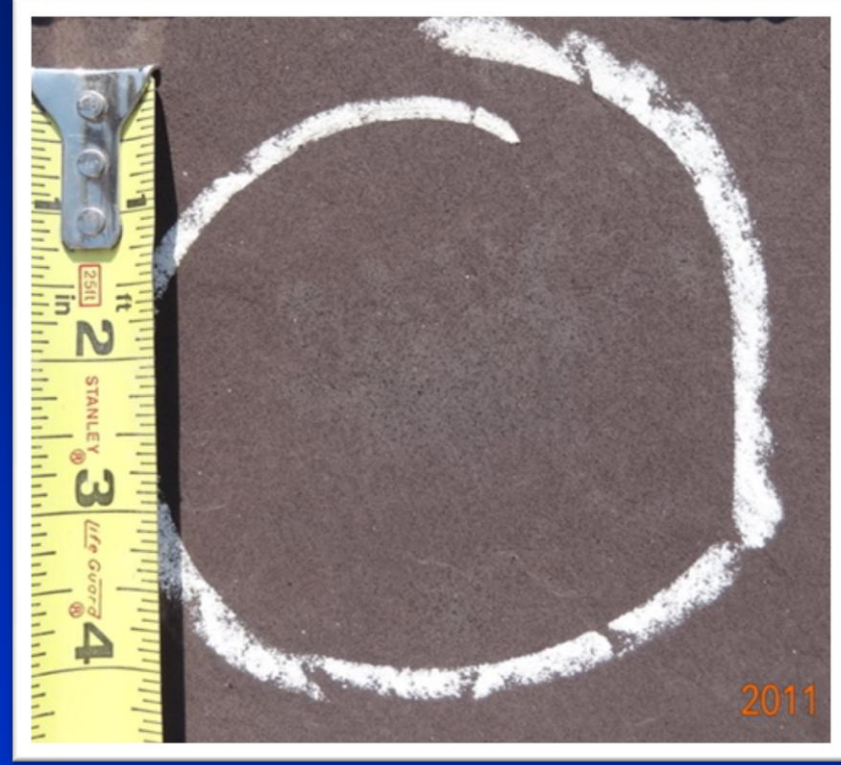
Site 6.07: No Fractures

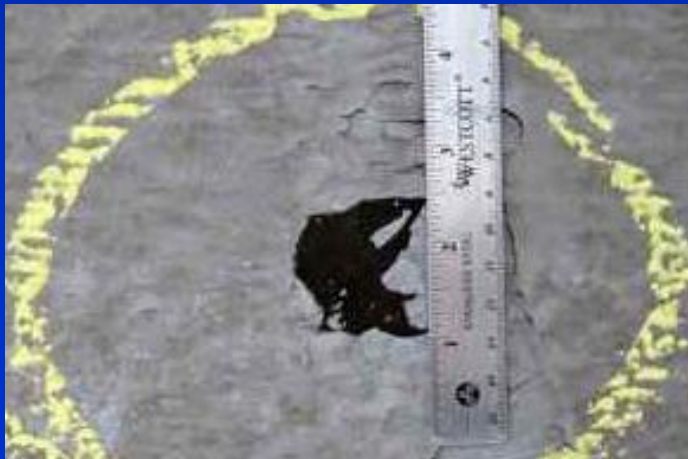
Site 4.08: Max Hail
size 2.25"

- Average damage rating 2.0
- Generally performed well on ballasted systems with hail sizes up to 2.5 inches in diameter
- Only BUR with severe damage struck with 3" hail

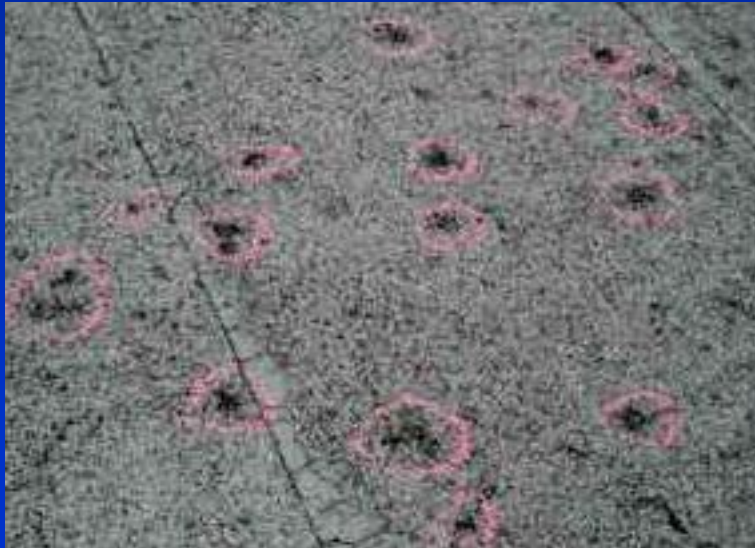
Site 4.06, Max
Hail Size 2.5"

- Average damage rating of 3.75
- Moderate or severe damage when hail size 2" diameter or larger.
